Runway Overrun During Rejected Takeoff  
Ameristar Air Cargo, Inc.,  
dba Ameristar Charters, flight 9363  
Boeing MD-83, N786TW  
Ypsilanti, Michigan  
March 8, 2017

NTSB/AAR-19/01  
PB2019-100293

# Aircraft Accident Report

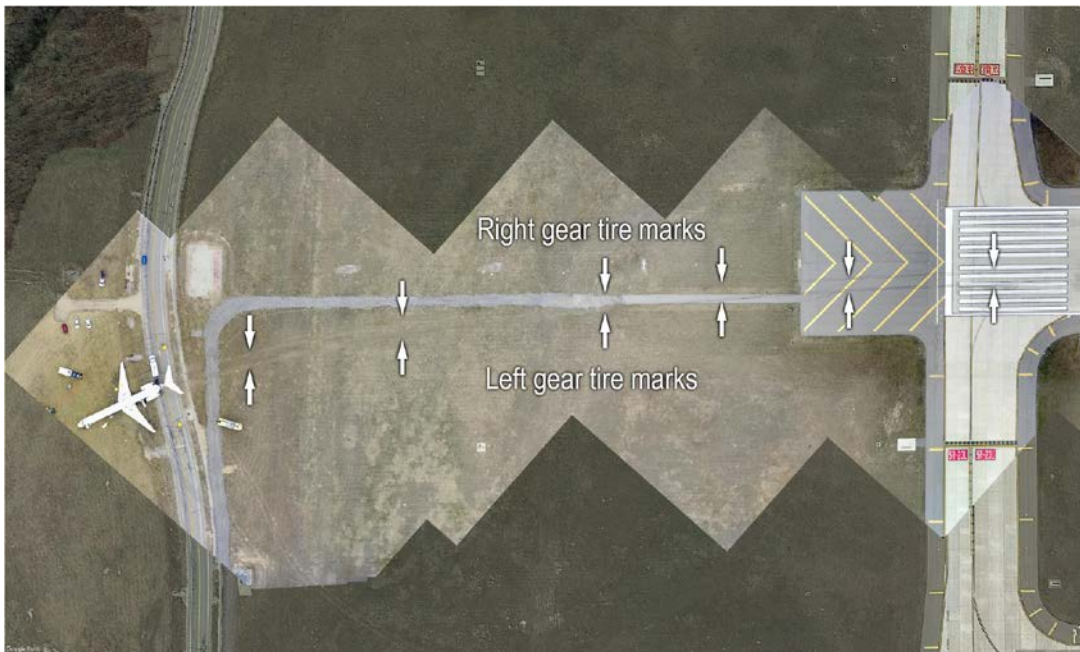
At 1452:23, the CVR captured sounds consistent with the airplane's excursion from the paved surface. The airplane exited the paved surface off the departure end of runway 23L (including a 200 ft blast pad) and traveled about 950 ft across the grassy part of the runway safety area (RSA) before striking the airport perimeter fence and a raised, paved road before coming to a stop. The airplane came to rest on the fuselage belly with the tail on the road, about 1,150 ft west-southwest of the end of the runway (see figures 1 and 2).

**Figure 1.** Orthomosaic image of the airplane's path from the end of runway 23L to its final location.

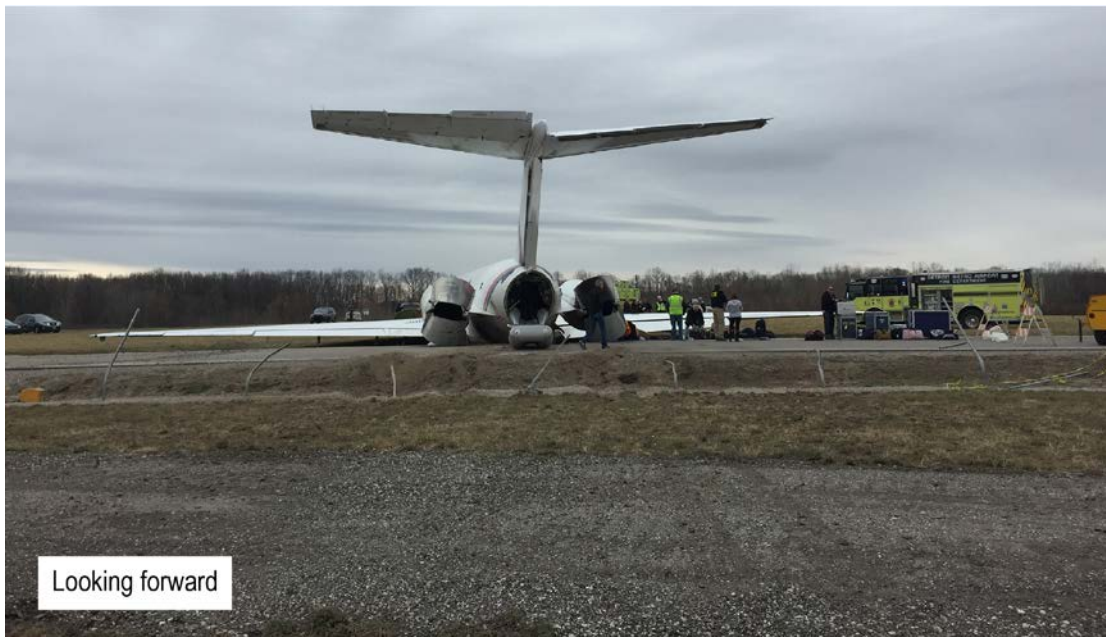
**Figure 2.** Rear view of the airplane wreckage.

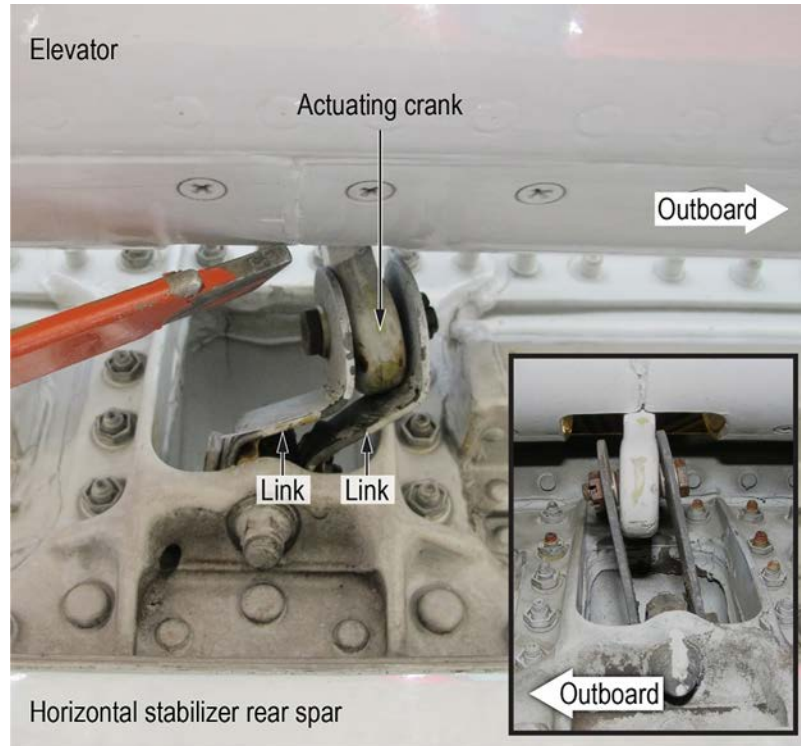
Using a lift to access the elevators, investigators found that the airplane’s right elevator was jammed in a TED position and could not be moved when manipulated by hand. Examination found that the inboard actuating crank for the right elevator’s geared tab was bent outboard, and its links were bent (see figure 6). Further, the actuating crank and links were found locked overcenter beyond their normal range of travel (see figure 7).

**Figure 6.** View of accident airplane’s elevator geared tab links and actuating crank in an overcenter position with links bent outboard. Inset shows undamaged exemplar links and actuating crank in an overcenter position.

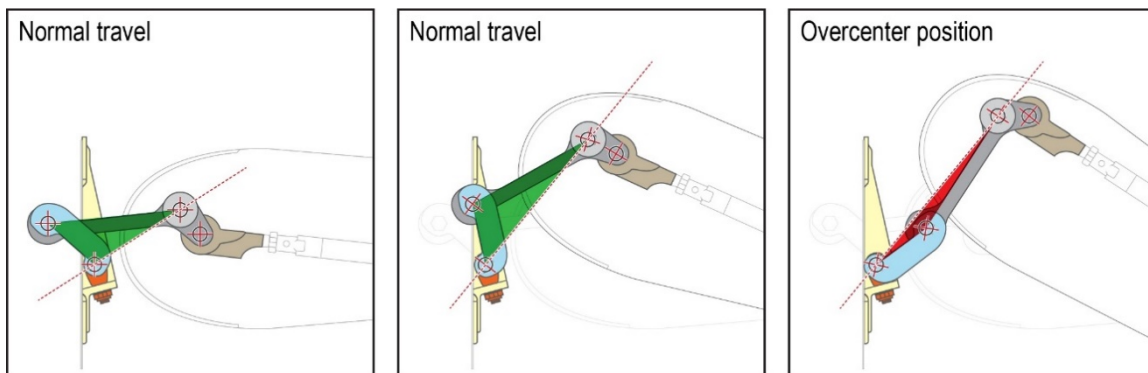
**Figure 7.** Diagram showing the relative positions of the links (blue) and actuating crank (gray) when moving within their normal range of travel (in green) and when locked overcenter after having moved beyond their normal range of travel (in red).

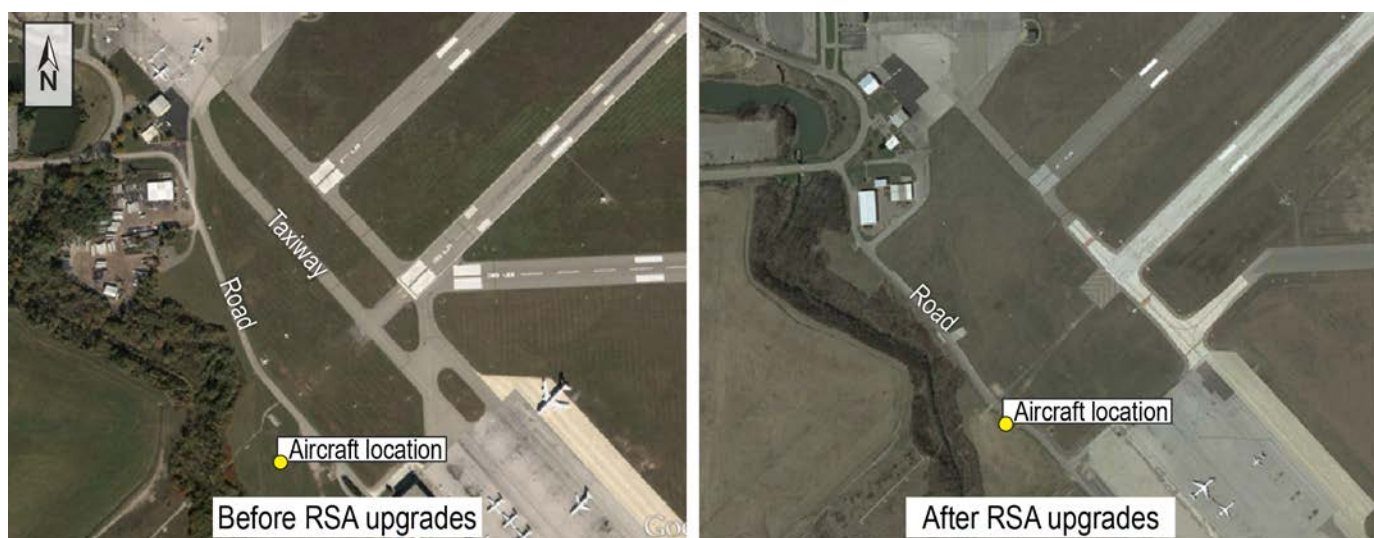
The FAA stated that improving the RSAs on the ends of runways 5R/23L and 5L/23R involved land acquisition, filling in a ravine (the maximum depth of which was 30 ft in some locations), removing a taxiway, moving or making frangible approach lighting systems, removing structures and concrete markers from the RSA, and moving the perimeter fence and a road about 200 ft. The YIP RSA improvement project had cost \$20 million, with a federal investment of \$19 million. Figure 8 shows aerial photographs provided by the FAA of the RSA off the end of runway 23L both before and after the improvements.

**Figure 8.** Photographs of the RSA off the departure end of runway 23L before upgrade (left) and after (right).

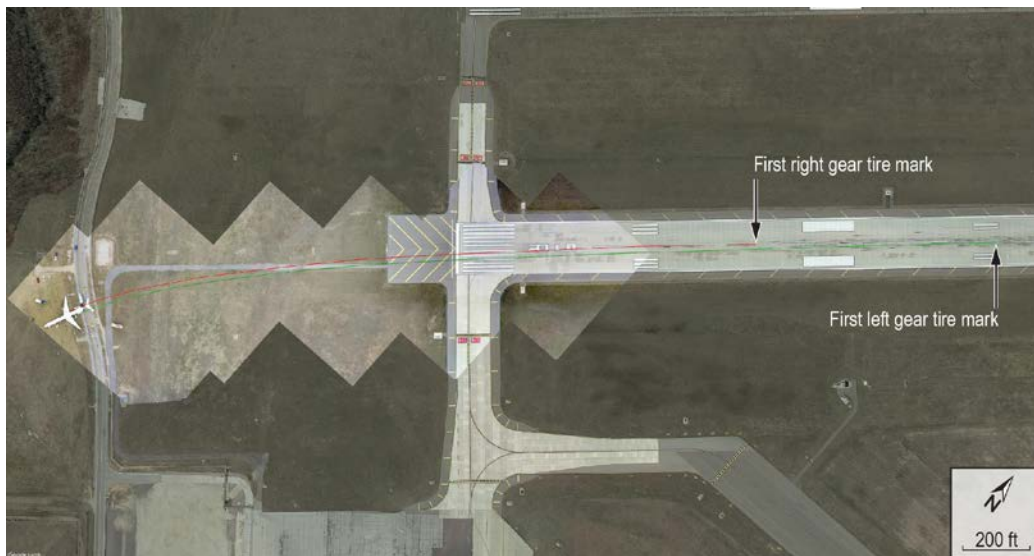
**Figure 9.** Orthomosaic image showing runway, airplane, and annotated locations of tire marks.

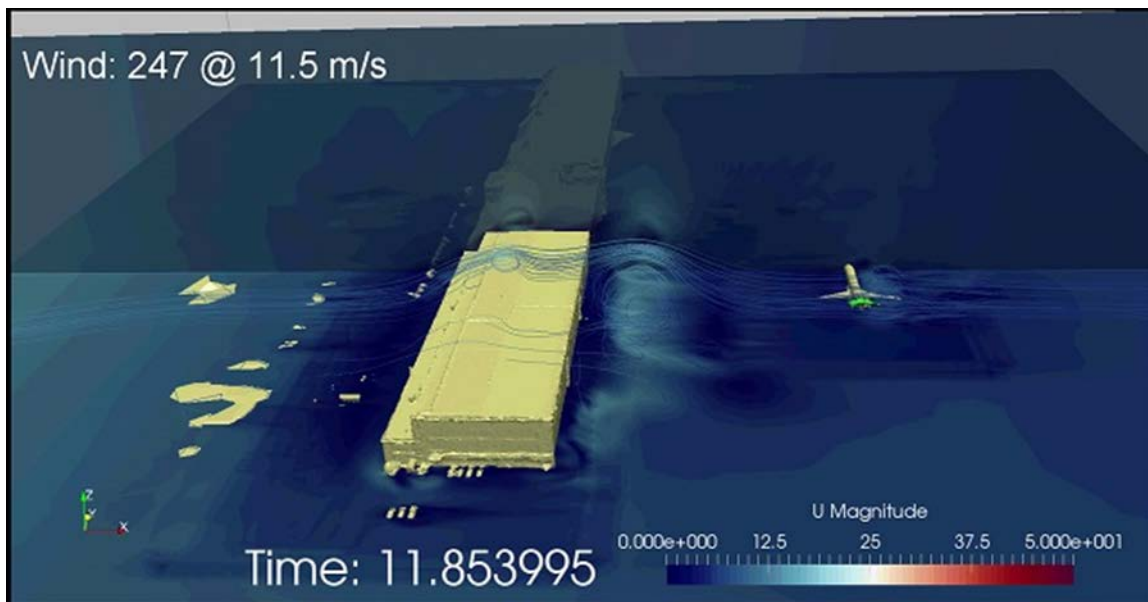
**Figure 11.** 3-D visualization of wind simulation results for a discrete time showing the locations of the hangar and airplane. Wind flow from the west (left side of image) is disrupted downwind of the hangar.

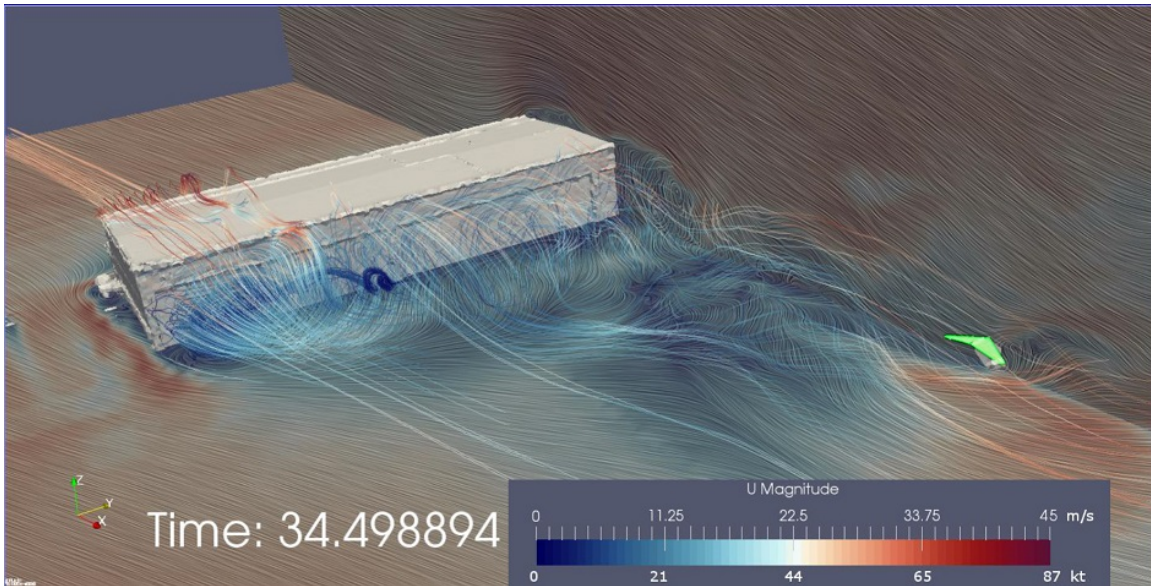
**Figure 12.** 3-D visualization of wind simulation results for a discrete time showing turbulence generated downwind of the hangar.

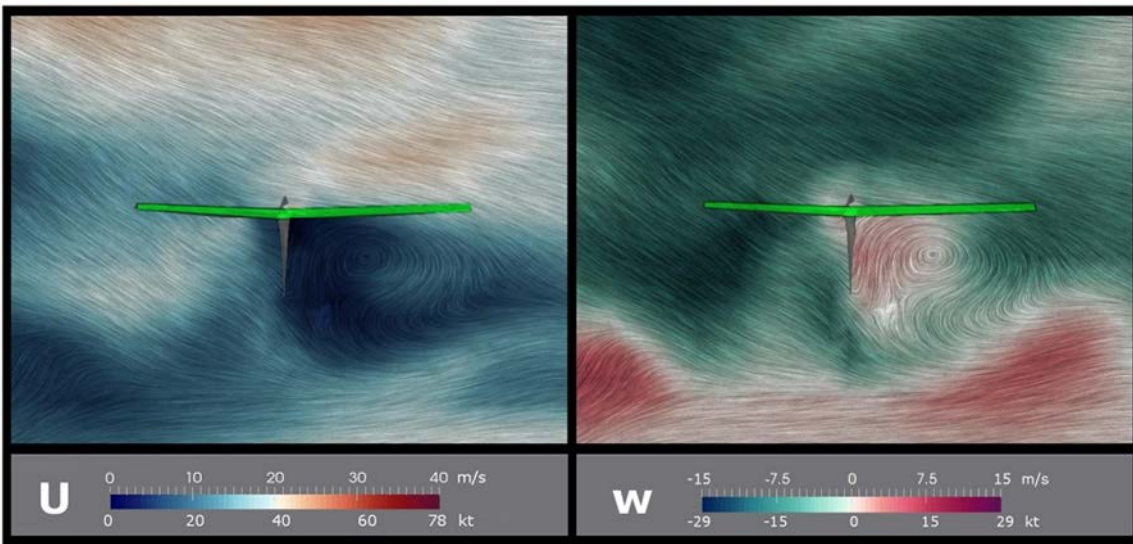
**Figure 13.** Vertical cross-section visualization of wind simulation results for a discrete time showing flow pattern and horizontal (“U”) and vertical (“w”) wind magnitudes near the accident airplane’s elevators (view from behind looking forward).

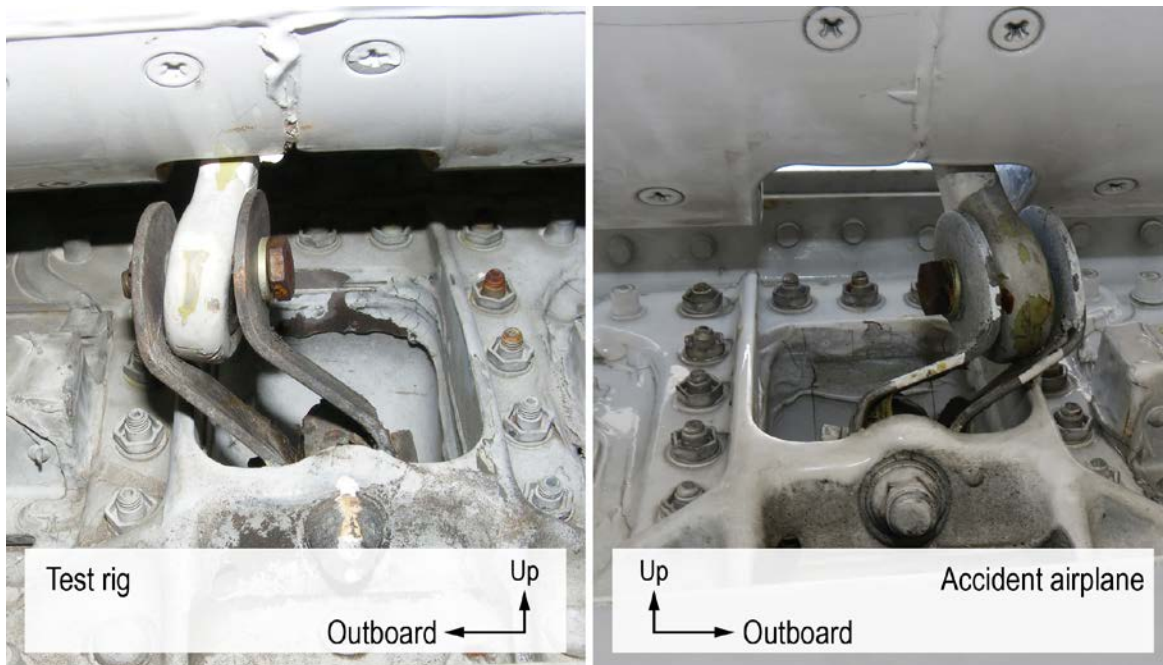
After the completion of the dynamic tests (described in the previous section), investigators sought to determine if adding a lifting force (to simulate airplane-nose-up air loading that would develop during the takeoff roll) would result in damage to the geared tab actuating crank and links similar to the damage observed on the accident airplane. With the geared tab inboard linkage in an overcenter position, an upward force was applied to hinge locations on the control tab. When the load cell reached about 800 lbs, the links began to fail; the load cell peaked at 975 lbs before the links completely bent outboard (see figure 15).

**Figure 15.** Damage to the left geared tab inboard links and actuating crank (left) after load testing versus damage observed postaccident on the accident airplane’s right geared tab inboard links and actuating crank (right).
